# **INDOOR AIR QUALITY ASSESSMENT**

**Massachusetts Rehabilitation Commission  
110 Mulberry Street  
Brockton, Massachusetts**

Prepared by:  
Massachusetts Department of Public Health  
Bureau of Environmental Health  
Indoor Air Quality Program  
October 2016

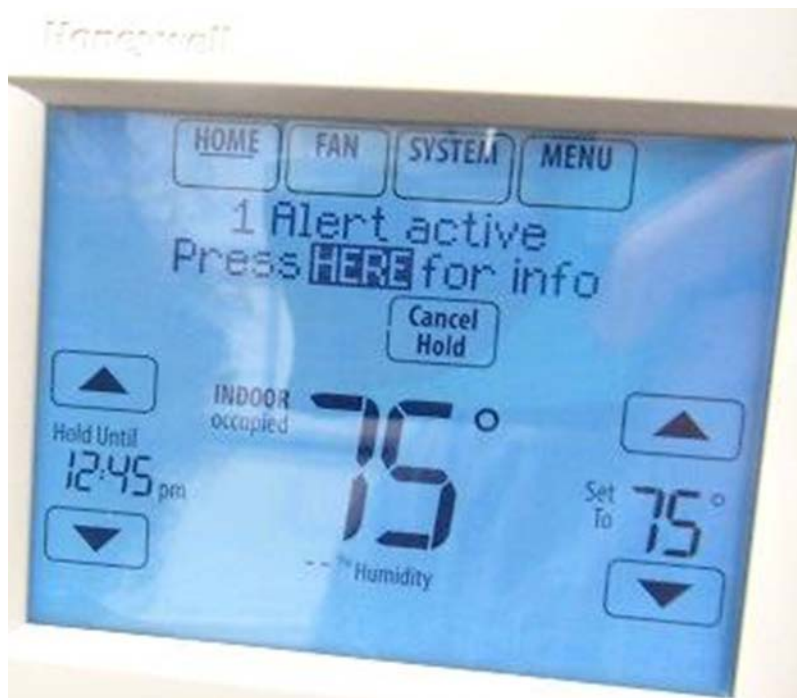
**Picture 1**

**Alert message on digital thermostat**

1. Work with building management/HVAC engineer to troubleshoot errors with digital thermostats/HVAC system. Once corrected, operate the system in fan “on” mode to provide *continuous* air exchange and filtration during occupied hours.
2. Consider modifying HVAC system to have all MRC areas on the same thermostat.
3. Continue with plans for carpet cleaning. Carpeting should be cleaned annually or semi-annually in soiled/high traffic areas as per the recommendations of the Institute of Inspection, Cleaning and Restoration Certification (IICRC, 2012).
4. Clean/disinfect AHU drip pans. Drip pans should be closely inspected for proper operation/draining and repaired/replaced as needed.

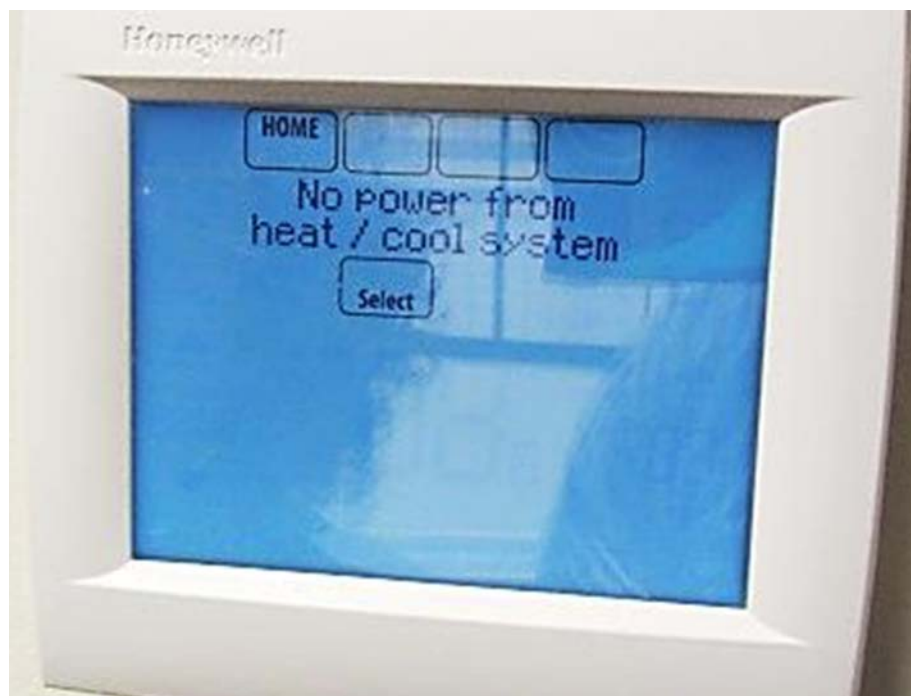
**Picture 2**

**“No power” message on digital thermostat**

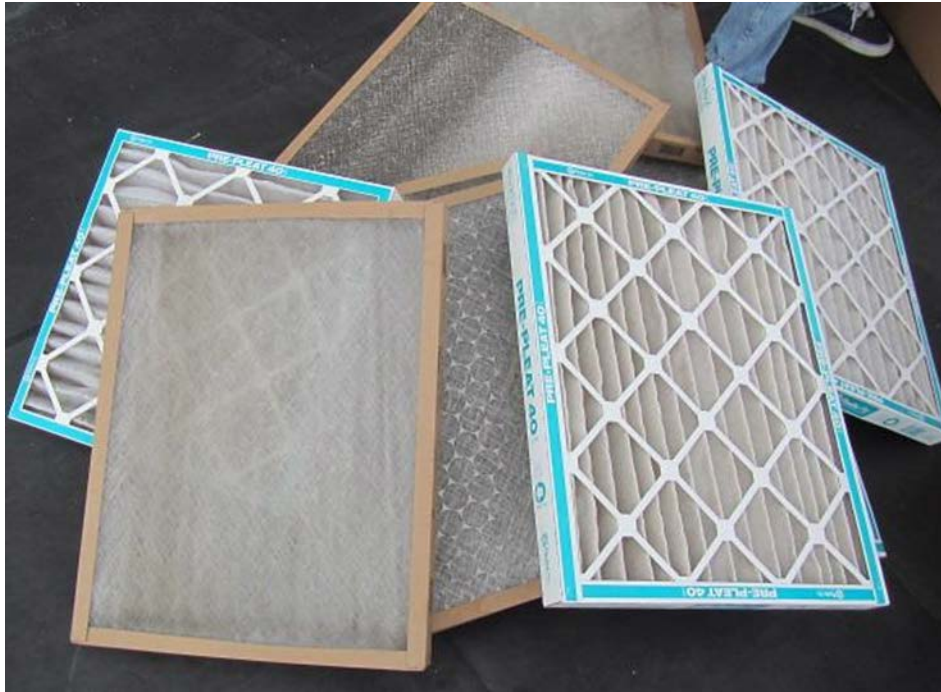
**Picture 3**

BEH/IAQ staff examined rooftop air handling units (AHUs). At the time of assessment, filters in AHUs had recently been changed. It was also reported that filters were upgraded from a low grade mesh-type filter to a more efficient pleated filter (Picture 3). The pleated filters currently installed were of a Minimum Efficiency Reporting Value (MERV) of 8, which should be adequate in filtering out pollen and mold spores.

**Low grade mesh filters on left, higher efficiency pleated filters on right**

9. Continue to change HVAC filters twice a year or more frequently if needed.
10. Refer to resource manual and other related indoor air quality documents located on the MDPH's website for further building-wide evaluations and advice on maintaining public buildings. These documents are available at <http://mass.gov/dph/iaq>.

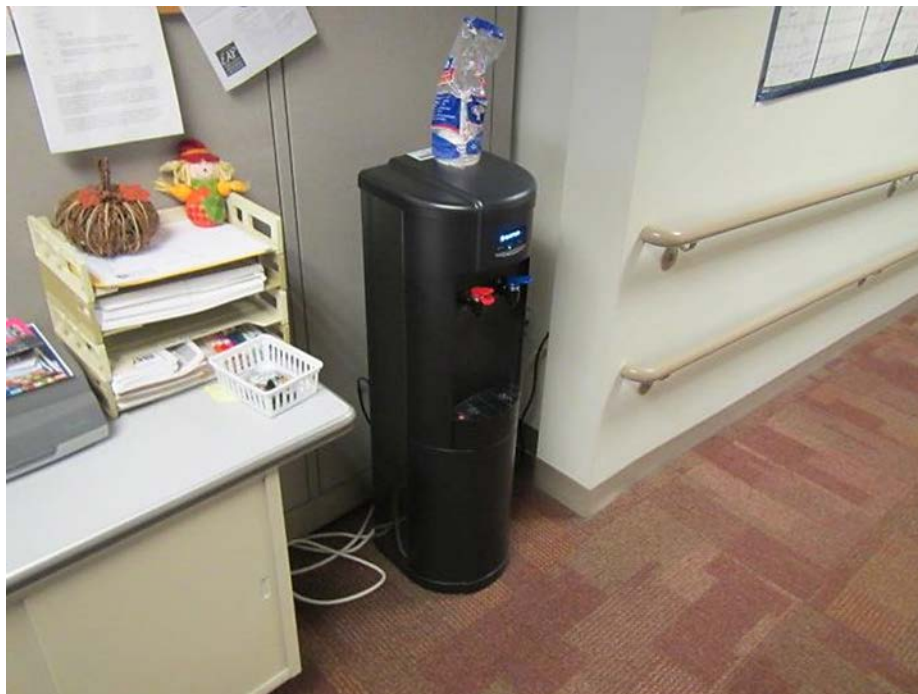
**Picture 4**

No evidence of water leaks or moisture to building materials in the MRC was noted during the assessment. A water dispenser was observed on the carpet (Picture 4). Leaks or overflow can moisten the carpet and lead to microbial growth.

**Water dispenser on carpet**

7. Ensure that procedures are in place and encourage occupants to report HVAC/maintenance issues so that they can be logged and repaired promptly.
8. Consider moving water dispensers to non-carpeted areas or install a waterproof mat underneath them.

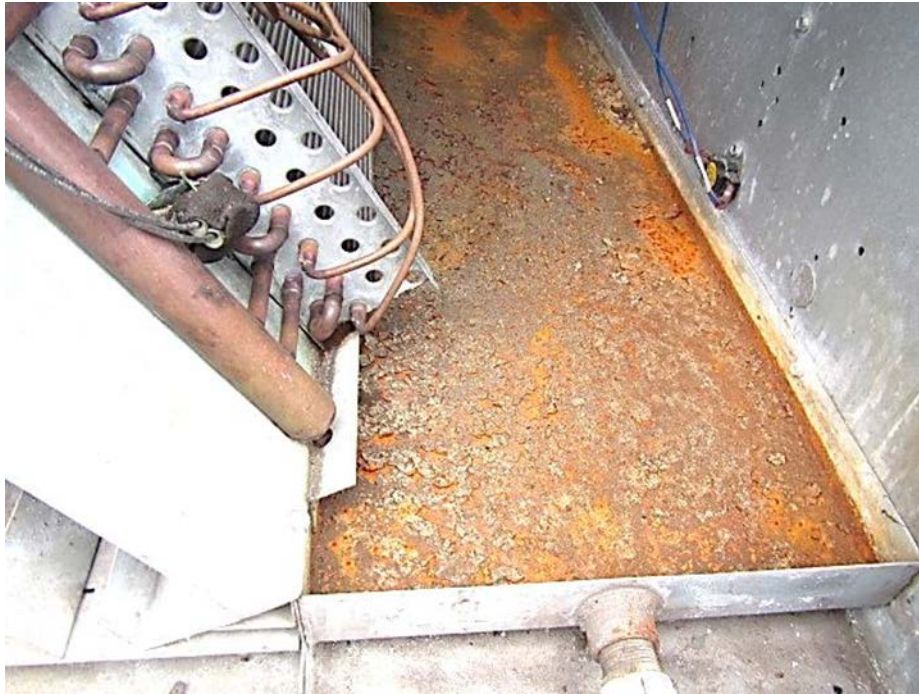
**Picture 5**

Upon examining rooftop AHUs, drip pans were found rusted/corroded and to have dried-up accumulation of scale/debris (Pictures 5 and 6), which may indicate they do not drain properly. Drip pans should be regularly inspected/maintained (e.g., cleaned during filter changes or prior to AC season) for cleanliness and proper operation.

**Rust/corrosion and debris in rooftop AHU drip pan**

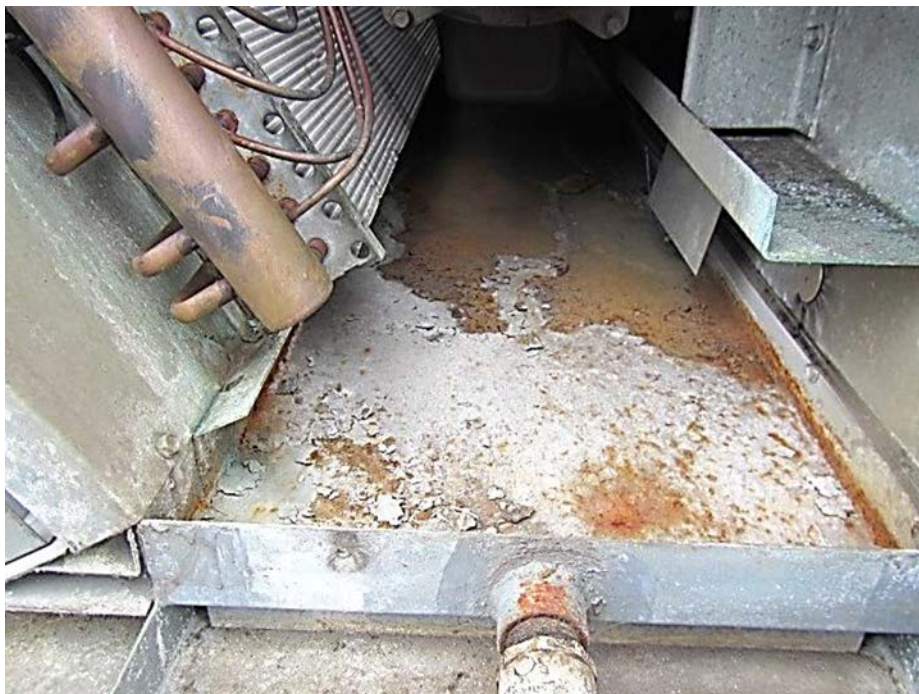
**Picture 6**

**Accumulated scale and debris in rooftop AHU drip pan**
